The Captain's tower in Bihac

Doc.dr. Maja Popovac dipl.ing.arh
Faculty of Civil Engineering
University "Dzemal Bijedic", Mostar
e-mail: maja.popovac@unmo.ba

Kapetanova Kula is situated in Old city core of Bihac, and it is proclaimed National monument under governmental protection.

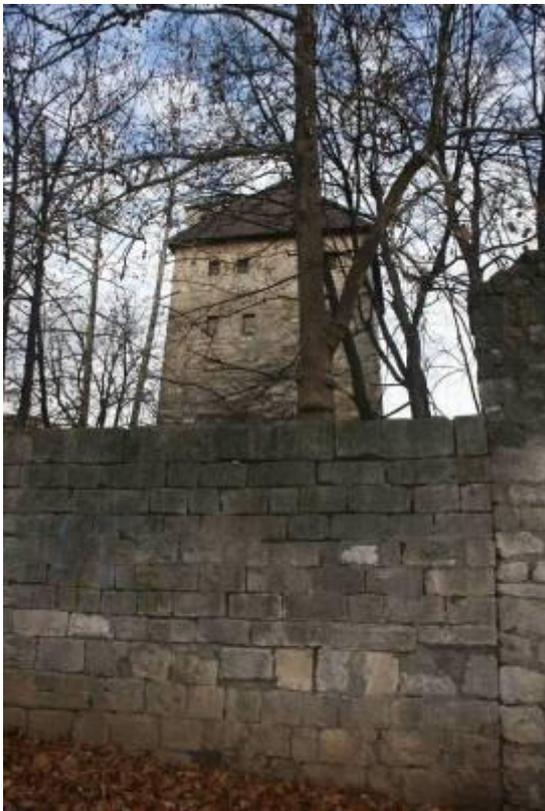
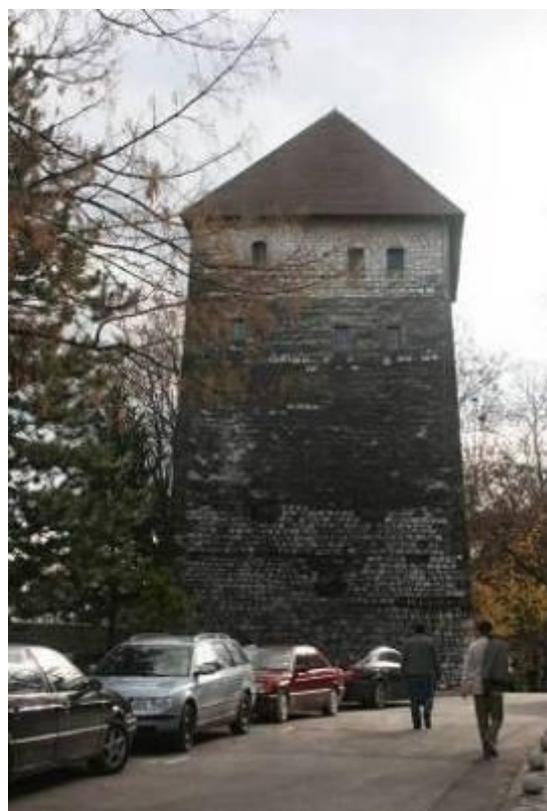
Today's condition of the monument is poor due to serious destruction of the façade by the atmospheric waters.

Figure 3. and 4. Captain's tower today

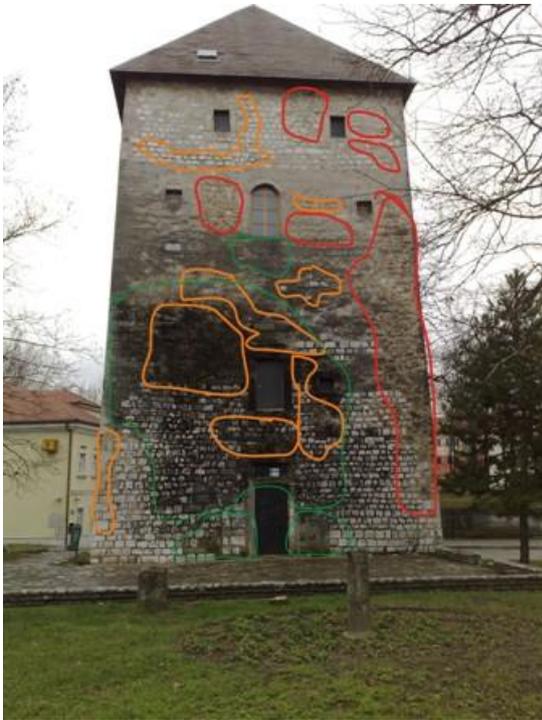
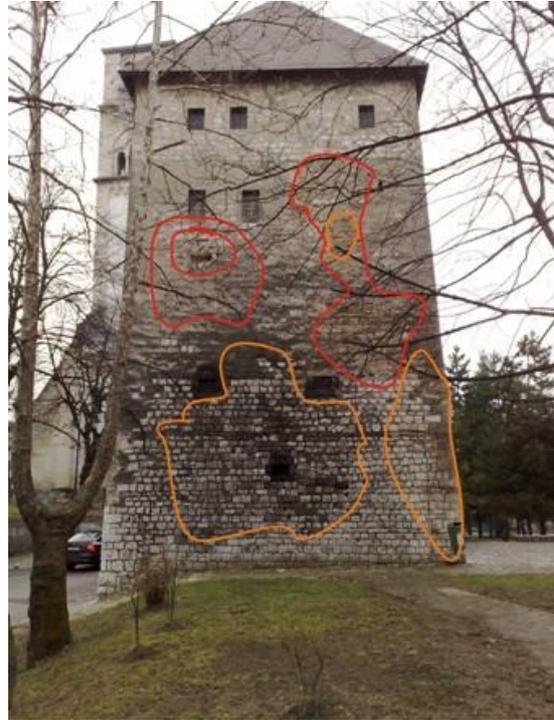
Current condition of the Captain's Tower is very serious. Seemingly stiff and solid structure of the Tower is damaged initially by the rain water, and the by different vegetation (grass, moos, small bushes).

Considering the fact that the Tower is situated at the highest spot of the plateau and that the most visible impairments are in the zone of the rain water affluence from the roof, the conclusion was unanimous – the water in the structure is coming from the cracks in the outer side of the walls.

Long time exposure to the atmospheric water and humidity in the walls contributed to destruction of the mortar on the façade and inside of the structure. Thanks to the admirable thickness of the walls, the situation is currently not critical, but if this

exposure to damaging factor continues – the problem will shortly cause serious structural damage.

Figure 8. and 9. Façade damage

Façade repair

This activity is the key for the longevity of the Captain's tower. They will be performed in few phases:

1. cleaning of the façade with metal and plastic brushes (joints and stone surface)
2. removal of the cement mortar
3. removal of the damaged lime mortar
4. replacement of the damaged and missing stone blocks
5. repointing of the joints
6. injection works (lime hydraulic mortar Rofix 993)
7. covering stone protection coating

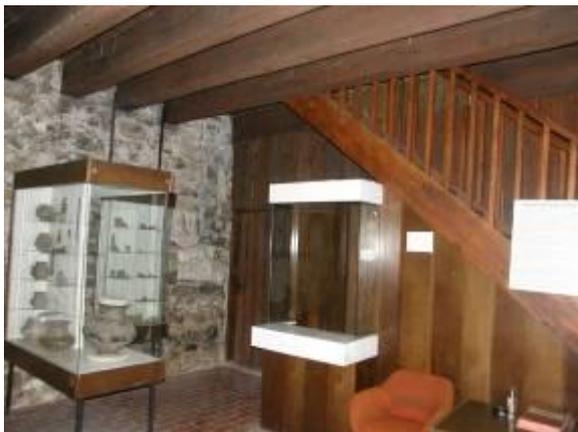
Every single wall carries traces of the cement mortar, inadequate repairs, electric cables and also burn in the ground floor. Last floor shows very visible reinforced concrete beam. In the ground floor there are some partitions made of different materials, mostly wood, which are unsuitable.

Figure 10. Ground floor today

Removal of the partitions in the ground floor

Dismantle all wooden parts and pay special attention to the brick wall laying on the inside part of the stone wall.

New flooring in the ground floor

After the injection works two 20cm layers of tampon (up to 30mm) will be laid. After that, 5cm thick stone pavement will be laid onto a layer of sand (1-4mm).

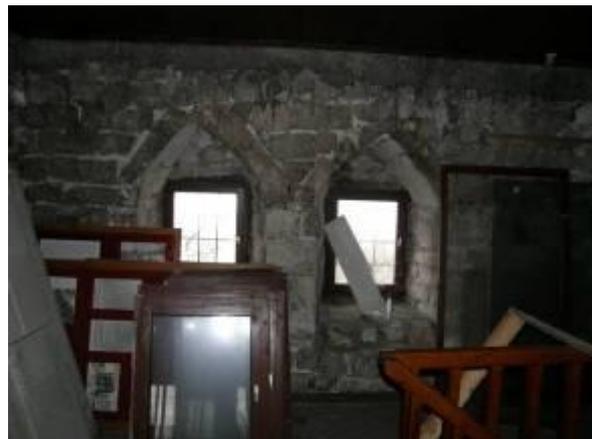
Figure 11. 4th floor today

Fourth floor shows reinforced concrete beams under the ceiling – it would require some minor removal of the concrete and same treatment as second floor.
