# INFRARED THERMOGRAPHY AND NUMERICAL METHODS IN CIVIL ENGINEERING

by S. Švaić, I. Boras and M. Hiti\*

*Faculty of Mechanical Engineering and Naval Architecture, University of Zagreb, Croatia*

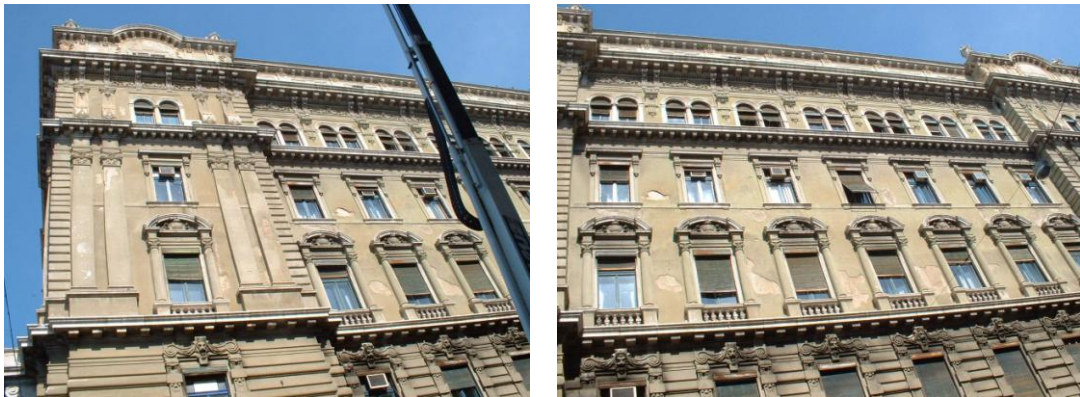
*Fig. 1 Photo of Jadrolinija Co. building facade in Rijeka, Croatia*

The measurements presented were carried out on the headquarter building of Jadrolinija Co., Rijeka (in February and May) and the medieval church St. George in Matesko Selo, Croatia.

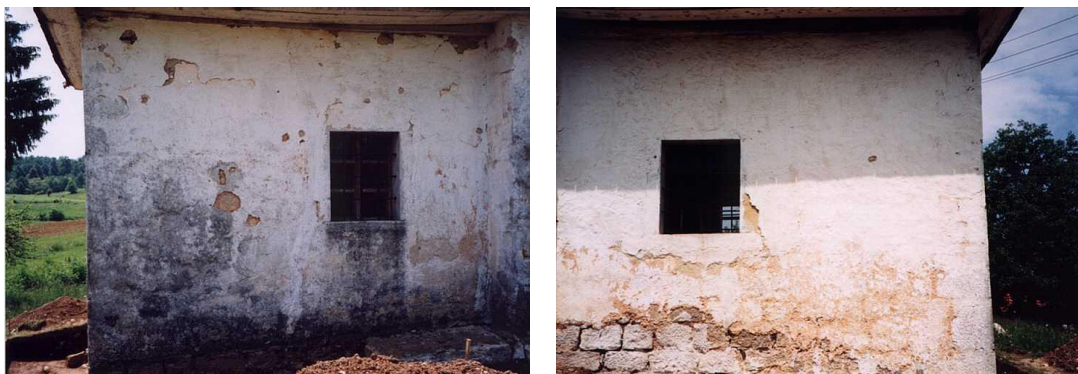
*Fig. 2. Photo of church St. George in Matesko Selo, Croatia*

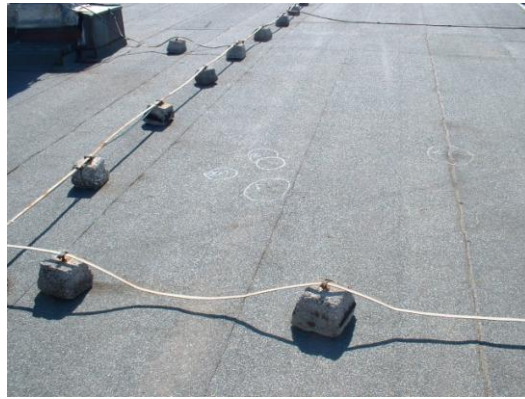
**Fig. 3.** Photo of flat roof (Jadrolinija Co. building)

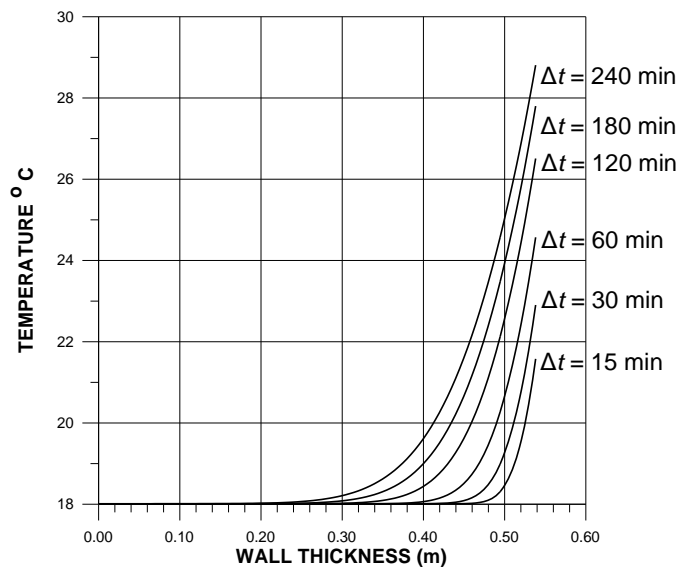
**Fig. 10.** Temperature distribution through wall cross section in different time steps

Figure 9 presents the results of outside wall temperature simulation for a time period of 4 hours. It can be seen that the maximum temperature gradient takes place in the beginning of heating of the wall structure. The temperature changes in the wall cross section is shown in Figure 10. The high heat capacity of brick and stone results in a very slow temperature change of this wall segment. Because of that it may be assumed that inside wall temperature will remain constant and independent on the changes of outside temperature during the period of simulation.

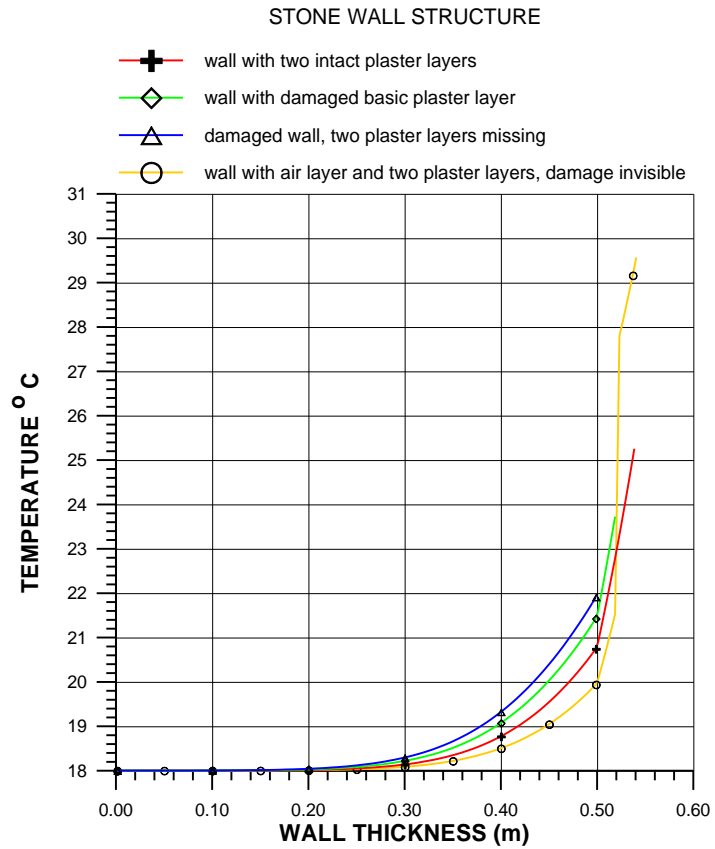
**Fig. 11.** Results of numerical simulation for building envelope having different defects (south facade)

Figure 11 shows the results of the numerical simulation of the south façade of Jadrolinija Co. building, Rijeka. The elapsed time from the start of heating is 4 hours.
