Application of principles of energy efficiency in the renewal of towns and cities with preserved historical and cultural complexes – a case study of Trebinje

The case study focuses on the building of the Museum of Herzegovina in Trebinje, which should also serve as a pilot project for the Trebinje town administration and the Ministry of Education and Culture of Republika Srpska, but also as a project that can be multiplied in the future.

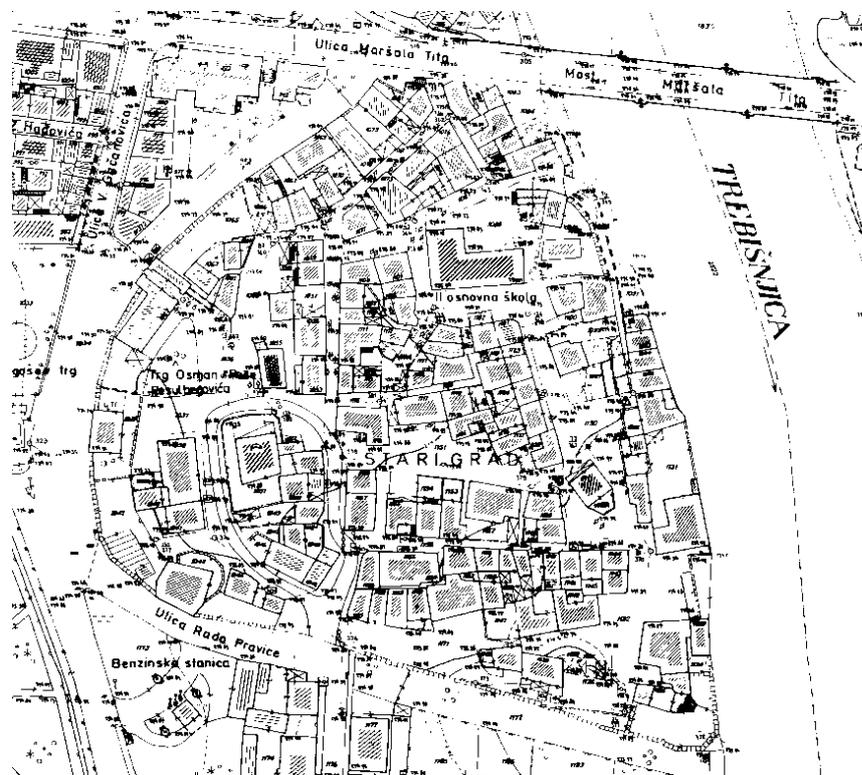
Figure 2. The structure of the Old Town

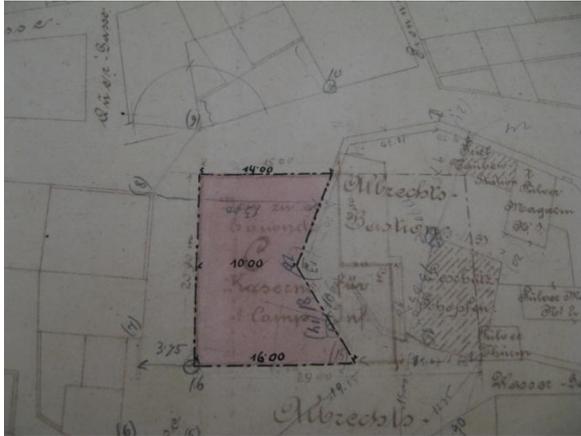
Figure 3. A sketch of the barracks site in the Old Town⁵

The building was constructed at the very beginning of the 20th century based on a blueprint whose original parts were discovered in the Archives of Bosnia and Herzegovina (Figures 3-5).

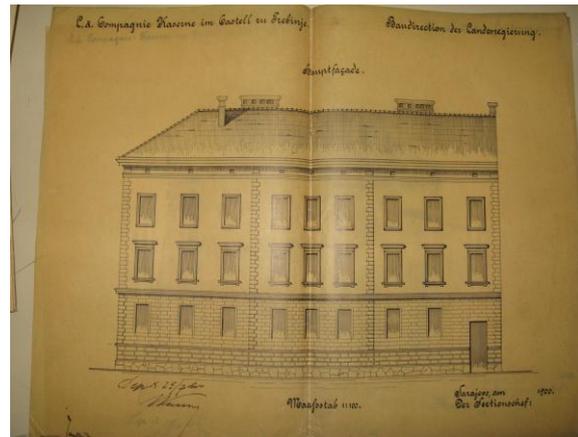
Figure 4. Part of the original design, dated 1900⁶

The inspection of the building and of the examination of the documents found in the Archive confirm the building was constructed to the 1901 design. Before the Museum was placed in the building, its condition was inspected (the floor structures) and a renovation project was made for the second floor ceiling. In 2010, a project was prepared to adapt the attic into usable space, and these works are under way.

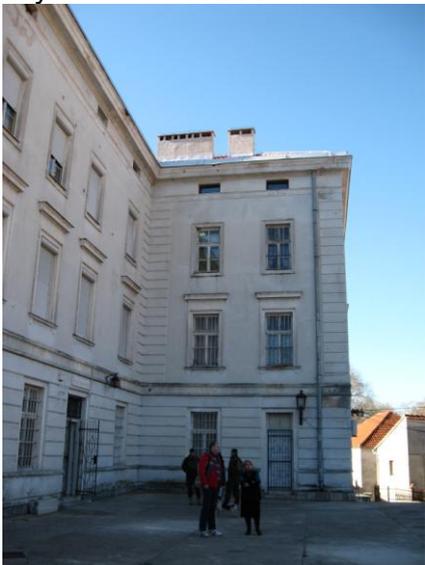
Figure 6. The northwestern facade

The building is made of stone and it is assumed it was constructed in the stead of an ancient church dating back to the 4th century, which may have been the location of the old settlement of Trebinje.

Both the outside and inside walls of the building are load-carrying walls made of stone; they are in good condition, with no visible cracks or signs of dampness (heat transfer coefficient $U=1.395 \text{ W/m}^2\text{K}$)

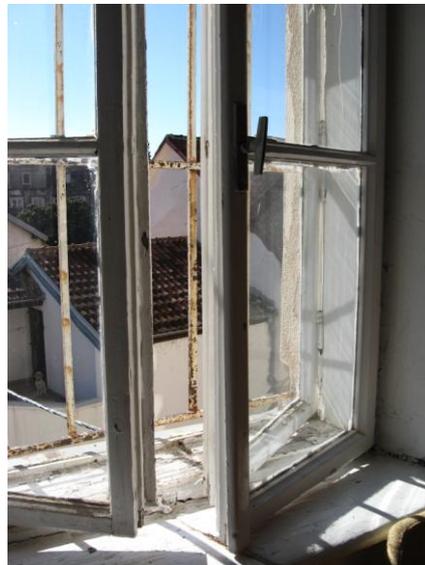
Figure 7. A museum window

The exterior windows and doors are in very bad condition (the windows in most of the rooms are not opened for fear they might come off or fall apart). They are single-glazed, double casement windows, set in broad box frameworks.

It is planned to replace all exterior windows and doors with new ones having better insulation properties. As the building is listed, it is not possible to install superwindows, as triple glazing would change their appearance. The most acceptable solution would be to replace them with double-pane insulated glazing, which would considerably upgrade their performance. In case this solution is impossible, the exterior panes should be single glazed and the interior ones double glazed; outdoor blinds should also be installed as protection against overheating.

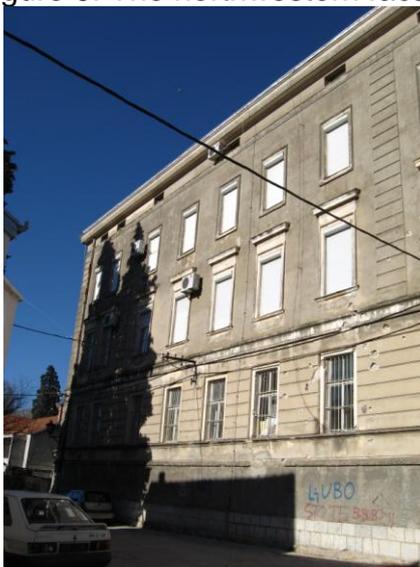
Figure 8. The south facade
