Energy saving in historical school buildings: Mission impossible?

ABSTRACT

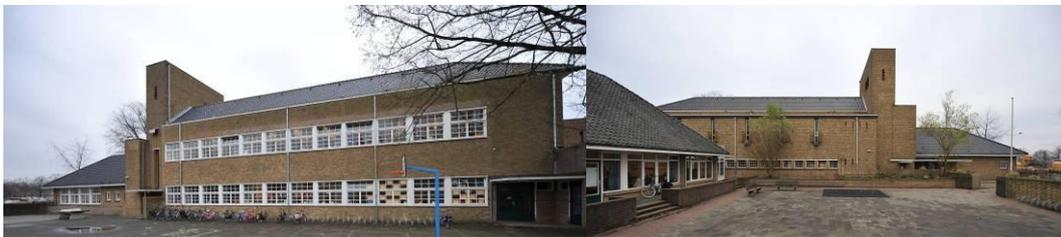
Figure 2. Photos of the Minckelersschool.

The '*Minckelersschool*' is composed of two originally separated buildings. They became connected by a new element in the 1980's. This new element is realized in the same style as the older buildings. The main building was realized in 1927 and is designed by architect Dudok. It houses the classes 3-8 of the primary school. The *Minckelersschool* is a special example for the architecture of this period because of it's historical and architectural values, it's special ensemble and it's integrity.

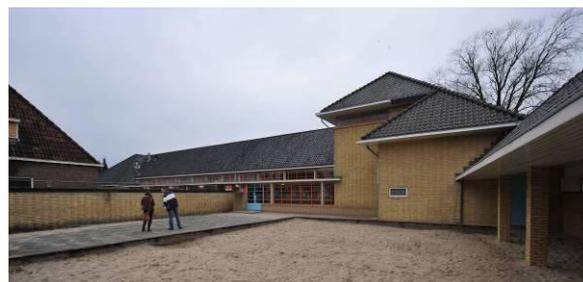
Figure 3. Photo of the Nelly Bodenheim school.

The '*Nelly Bodenheim*' school belongs to the ensemble of the '*Minckelersschool*' and houses the classes 1-2. This building was realized in 1929 and is also designed by Dudok.

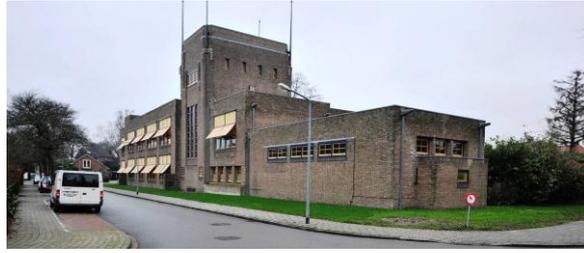
Picture 4. Photos of the Violenschool International.

The '*Violenschool International*' is built in 1919-1920, designed by Dudok, too. Today, also a kindergarden uses parts of the building. The structure of the building and many details are still original. In 2001 the school is carefully renovated by an experienced restoration architect. Preservation of historical values got high priority during the restoration.

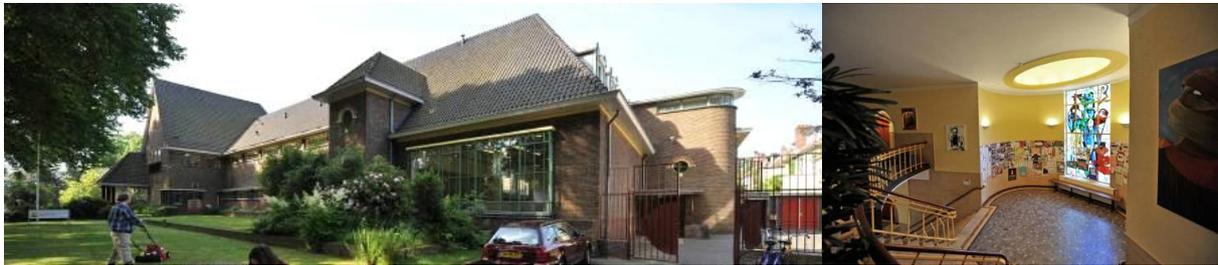
Figure 5. Photos of the Alberdingk Thijm College.

The '*Alberdingk Thijm College*' was built in 1937-1938, designed by architect Nicolaas Andriessen. Today it houses an international primary and secondary school. The style of the original part is 'expressionism' and it is obvious that there are influences of Dudok and the early designs of Frank Lloyd Wright. In the 1950's a new part is added to the original school building, thus creating a protected schoolyard.

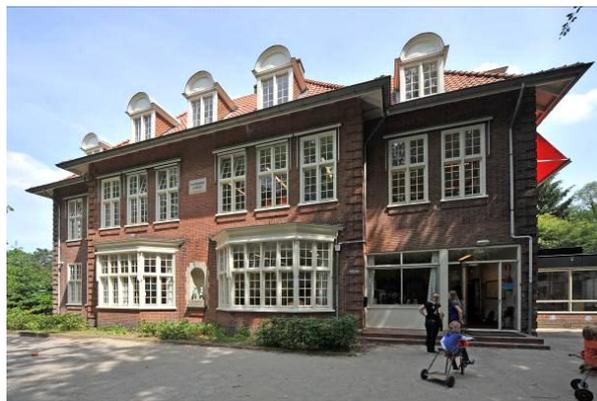
Figure 6. Photo of the Godelindeschool

The '*Godelindeschool*' is a primary school, built in 1904. It is the only case study that is built before the period of Dudok. The building is designed by architect Hanrath, who designed many mansions in Hilversum and the surrounding of the city. In 1919 and in 1928 his son designed two new parts, in the same style as the original school. Characteristical elements for Hanraths architecture are the use of bricks, the valiant

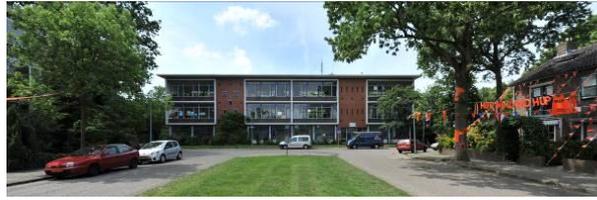
Figure 7. Photo of the 'De Wissel'

The school 'De Wissel' houses a practical school for children with learning disabilities. Built in 1960-1961 it is the only case study that is realized after the period of Dudok, designed by architect Joustra. The building has a concrete structure with columns on the ground floor. On the first and second floor walls are situated perpendicular to the long façades.

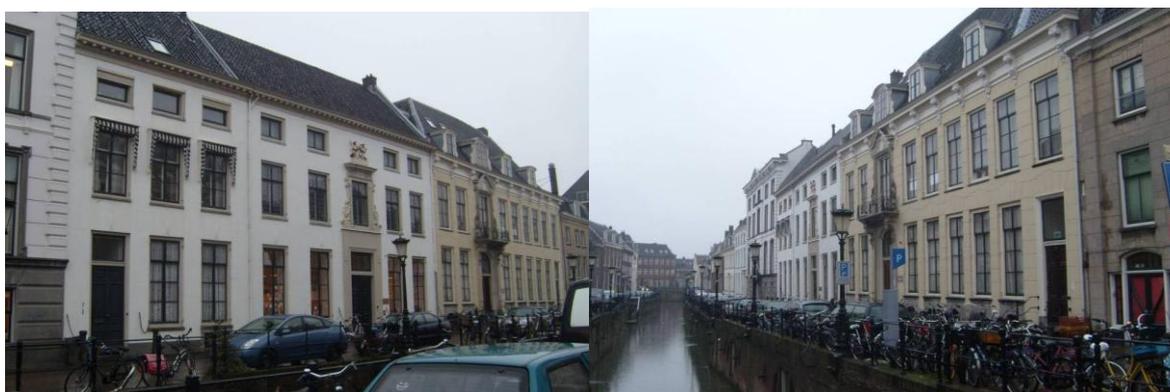
Figure 12. The photos above show the Cathedral Choir School in Utrecht. ⁴

Since the 16th century the building which now houses the school formed together with the neighbor house, No. 7, a large mansion, where rich families lived. In the 17th century in both buildings, No. 5 and 7, identical windows were made in the forefront. It was then, too, that all over the house a new continuous roof was made. This created a very broad and patrician mansion. Probably the façade was not yet

In 2008-2009 the school building was restored on the outside. In the current situation the children use the entrance in the basement, located at the rear. In the basement there is the wardrobe for the children and a small library. Luckily there are no moisture problems in the basement. At ground level an expansion is realized where the director's office is situated. At ground level and on the first floor there are three classrooms and additional rooms for the music lessons. The class rooms still are high rooms, without the in primary school often applied false ceilings. Despite the high windows it is necessary to turn the lights on during the day. The building is not insulated. The windows have wooden frames and are all fitted with single glazing, except the windows in the concert hall which got second windows behind the original ones. There also are many air leaks. Nevertheless, the owner thinks about installing a mechanical ventilation system with heat recovery in order to improve the indoor climate. The school needs more rooms for educational functions and therefore wants to realize changes in the rooms on the second floor, eg remove some interior walls. In order to make the attic suitable for educational functions interventions in the construction of the roof are inevitable and new skylights are needed to meet the requirements for daylighting. The roof is not insulated, either. Like the neighbor houses the school makes use of the district heating system. The installation is located in the basement of the neighboring building.
