The Captain's tower in Bihac

Doc.dr. Maja Popovac dipl.ing.arh
Faculty of Civil Engineering
University "Dzemal Bijedic", Mostar
e-mail: maja.popovac@unmo.ba

Kapetanova Kula is situated in Old city core of Bihac, and it is proclaimed National monument under governmental protection.

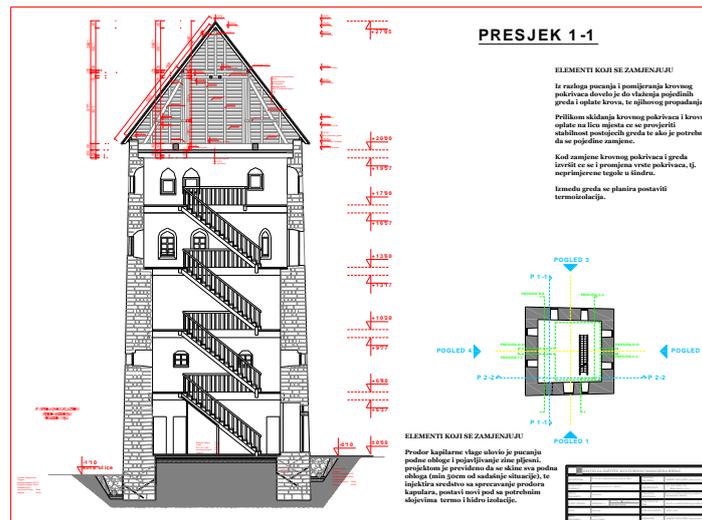
Figure 5. Captain's tower – cross section

Variation in winter day/night temperatures are very unfavourable for the Captain's Tower masonry. The ice on the structure surface is melting during the daily sun, and in the form of water it is getting deeper in the joints and cracks. During the night, with minus temperatures, the water froze – making further damage while it expands to ice.
