ELEMENTS OF ENERGY SAVING IN THE RESTORATION PROJECTS

Dubrovnik, April 2011

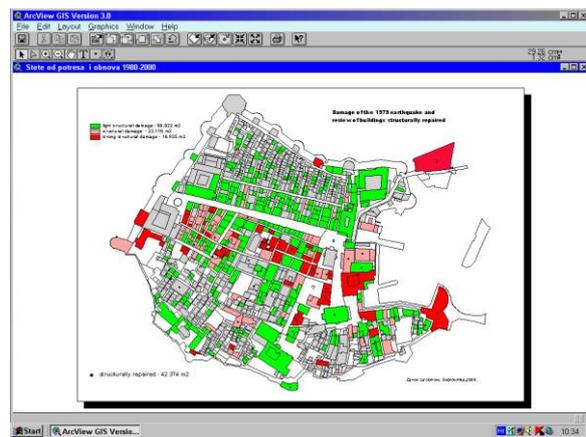
Figure 2 The map of damages

The cultural entirety of Dubrovnik is the area of the historic city centre with its close surroundings, (Figure 1) placed on the UNESCO world heritage list in 1979. In the same year the City was badly damaged by the earthquake of intensity 7° MCS scale when 833 objects were damaged. The estimated damage in 1980 was over 436 million US\$. (Figure 2).

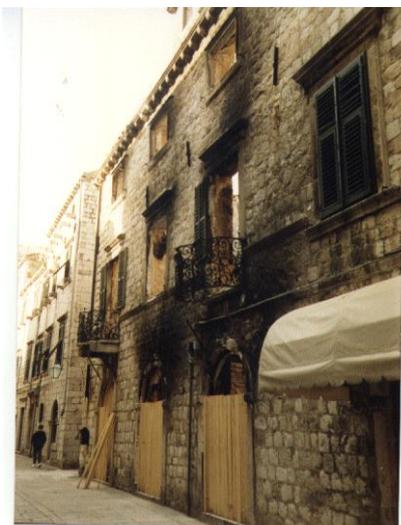
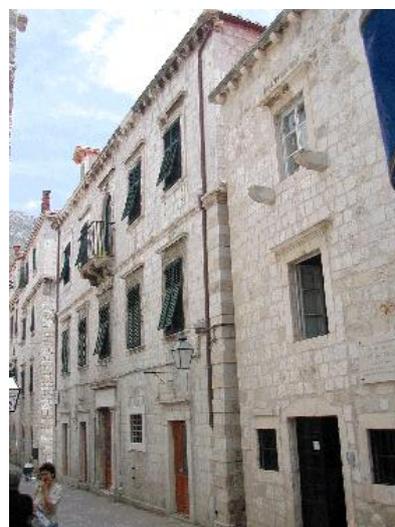
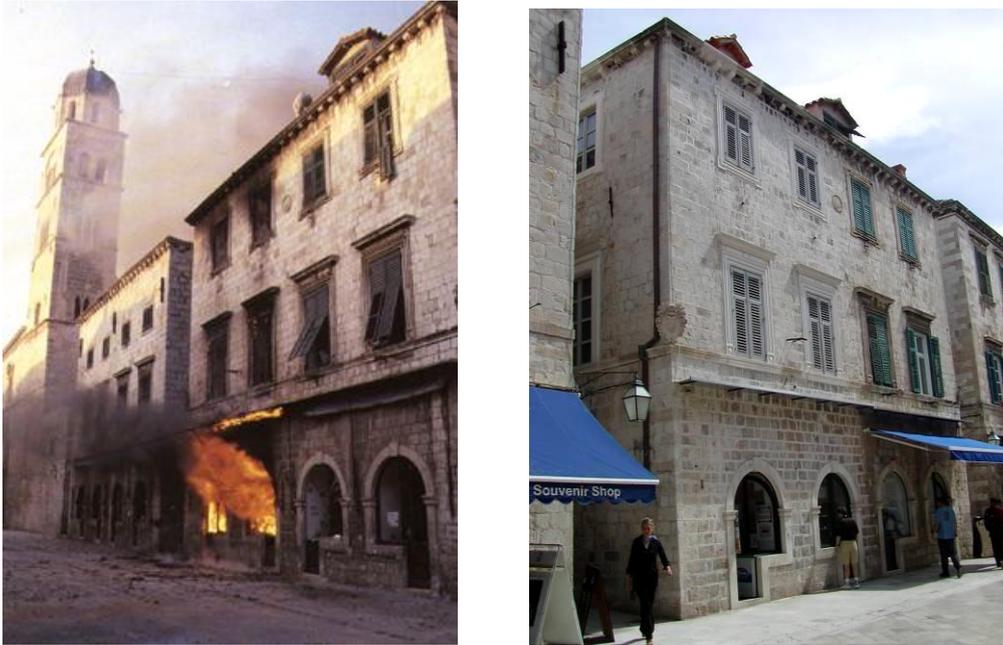
Figure 5 The pictures of the restoration from the war destruction

In the war destruction of the City the damages were registered on 473 objects and 70% of the roofs in the City, which was estimated on the amount of 20 millions US\$. Since 1991 through the Institute it was invested 19,7 millions US\$. for the renovation from the war damages. (Figure 5)

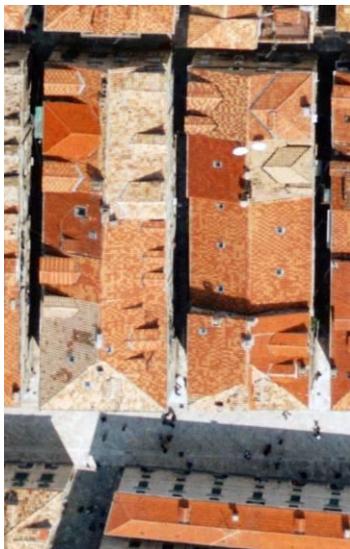
Figure 7 One outside wall

- predominant orientation on building the residential rows NE-SW (northeast-southwest) which ensures morning or afternoon's insolation of rooms
- urban matrix of construction in a row where buildings have only two outside walls in rows with a sewage canal '*klončina*' between, or one outside wall when two parallel rows are joined (Figure 7),

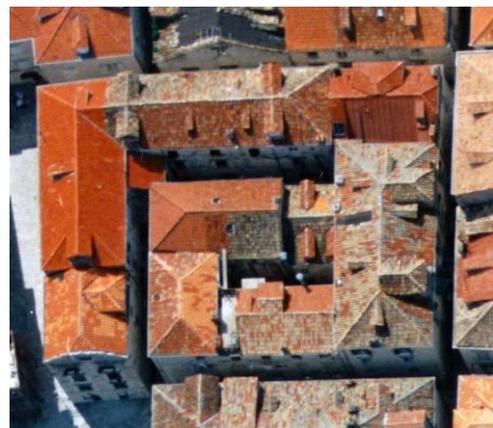
Figure 8 Block with only two outside walls

/ The rows NE-SW orientation/

- similar effects of joined masonry construction in a block also with only two outside walls (Figure 8),
- classic masonry of outside walls 60 – 80 cm thick which fulfils the thermal coefficients of the environment,

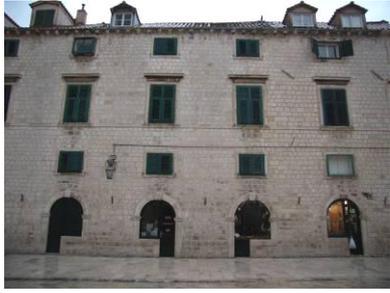
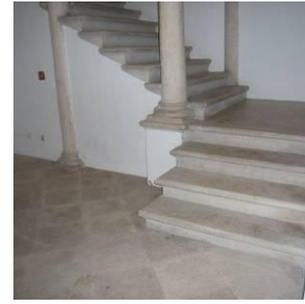
Figure 9 Low first and last floor Figure 10 Narrow high window Figure 11 Stone staircases

- low first floors (190 to 220 cm height) on the buildings where the storage of the ground floor was placed before, with small windows, or the last floor where the supposed space for attendants was placed (and looking after kids), all to function easier maintenance of the certain temperature (Figure 9),

- narrow high windows on the main floors enable the sun entry and the blinds put inside the windows to protect from the loss of heat (Figure 10),
- the use of materials in the interior like timber, tiles and stone define the kind of space, its purpose and the owner's status (partition walls made of timber and mortar, staircases' and floors – timber floors in small residential houses of several levels, in public buildings and palaces the stone staircase).(Figure 11).

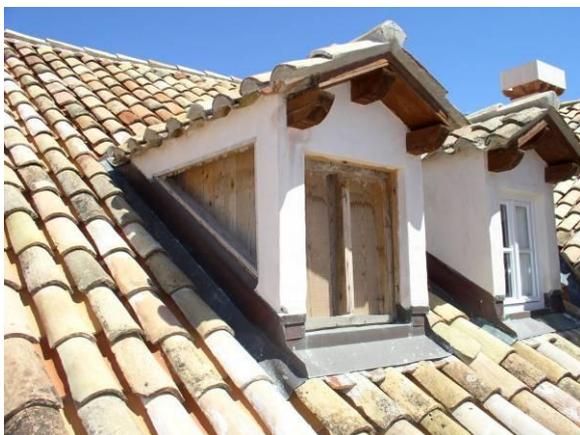
Figure 12 Roof windows

The central air conditioning is also planned to be built in the Bishop's Palace which renovation is being underway. It was inventively solved the air intake to the air conditioning plant room in the attic through the roof windows and hardly visible lifting of a tile (Figure 12, Figure 13).

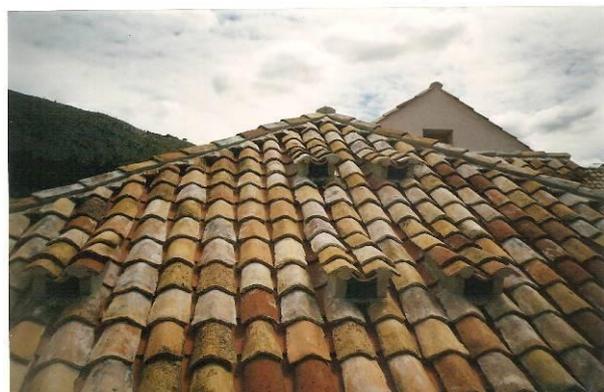
Figure 13 Lifting of a tile

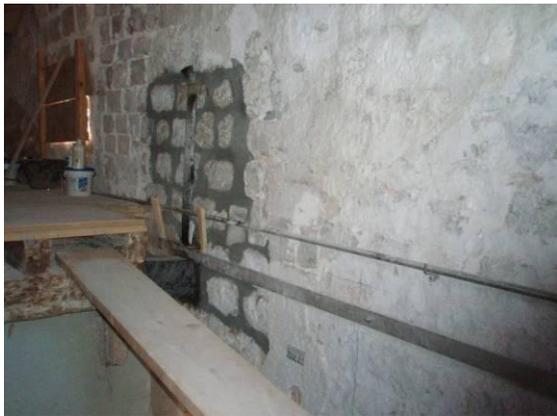
Figure 14 Rebuilding of low-quality masonry

- the rebuilding of low-quality masonry is done to reinforce and consolidate the masonry (Figure 14)

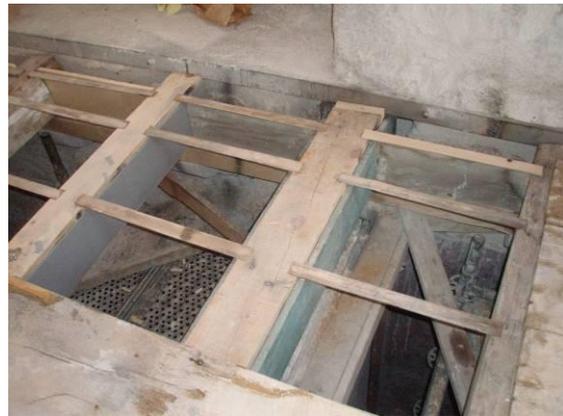
Figure 15 Constructive reinforcements

- constructive reinforcements are done and seismic risk diminished by mounting the stainless steel beams as well as performed composite construction in steel, mounting the timber glued *kerto* boards (instead of reinforced concrete slabs) which also serve as thermal insulators (Figure 15, Figure 16),
- the outside walls are plastered, facades made of porous stone are coated by hydrophobic materials to prevent moisture penetration into the walls,

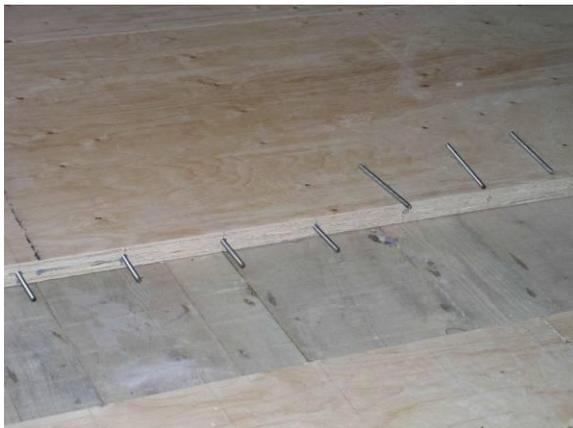
Figure 16 Kerto boards

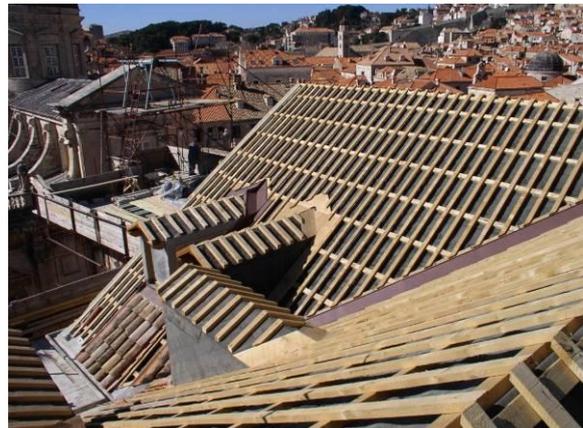
Figure 17 Roofs' renovation

- during the roofs' renovation all objects got 2, 4 cm thick board covers and the foil. This additional layer to the roofs diminishes the coefficient of heat passage and improves the physical properties of the building. (Figure 17)
- chimneys and damaged roofs windows are being repaired,
- the *iso* glass is mounted on the windows of the palaces where the complete renovation is being performed,
- the damaged stone ornaments of the facades and stone canals (caused by shell fragments) are being repaired to prevent moisture penetration into the walls.

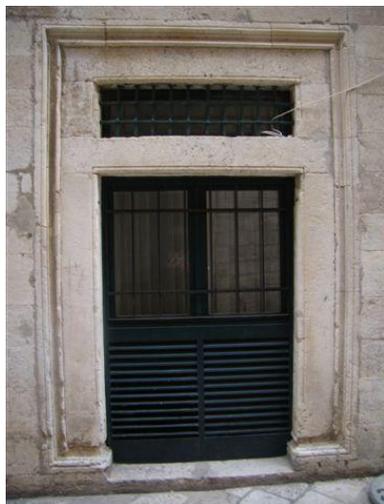
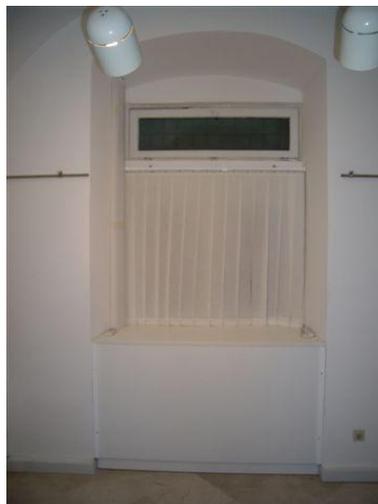
Figure 18 The use of the existing openings - outside and inside view

The recently built-in the multi split type air-conditioners by use of the existing openings (doors, windows), in cooperation with the Conservation department, is a good example of how contemporary solutions can be installed without disturbance to the authentic elements of the monuments (Figure 18).
