# **The facades technological updating of an icon of Brazilian modernist architecture: the case of the IRB headquarters building.**

The Brazilian Reinsurance Institute building, an icon of modernist architecture in Brazil, projected by MMM Roberto, is legally protected. Its facades had passed by some interventions which will be presented in this article.

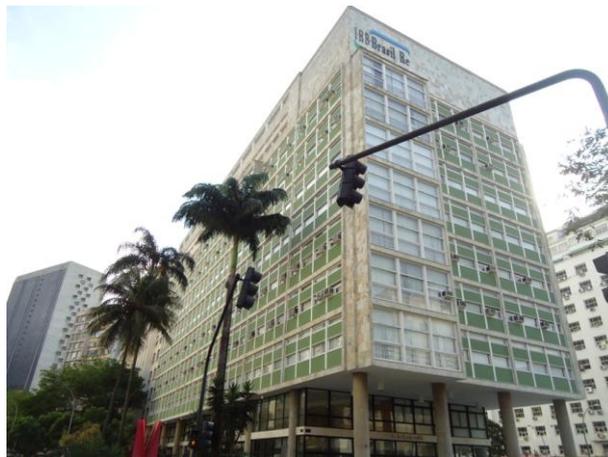
Figure 2. IRB Northeast and Southeast facades

The IRB-Re, a company active in state control of the reinsurance market, had its headquarters designed by the architects MMM Robert and opened in 1943. IRB is located in Rio de Janeiro downtown and its facades orientation been: northeast, the southeast and northwest (see figures 2 and 3).

In Rio, it's very important the shading protection of the facades, mainly in north orientation. In the case of IRB, the northwest façade was designed with *brises-soleils*, a common element of Brazilian modernist architecture. This element makes a shadow that contributes to the blockade the direct insulation.

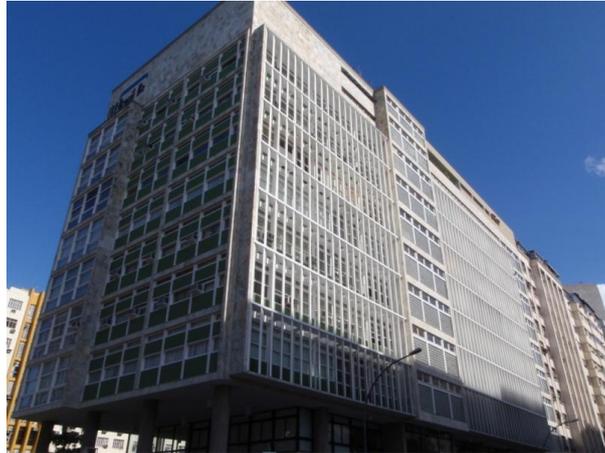
Figure 3. IRB Northwest and Northeast facades
